Design, Construction, and Analysis of CRCP Patching Techniques

Physical Research Report No. 124

March 1998

Illinois Department of Transportation
Bureau of Materials and Physical Research

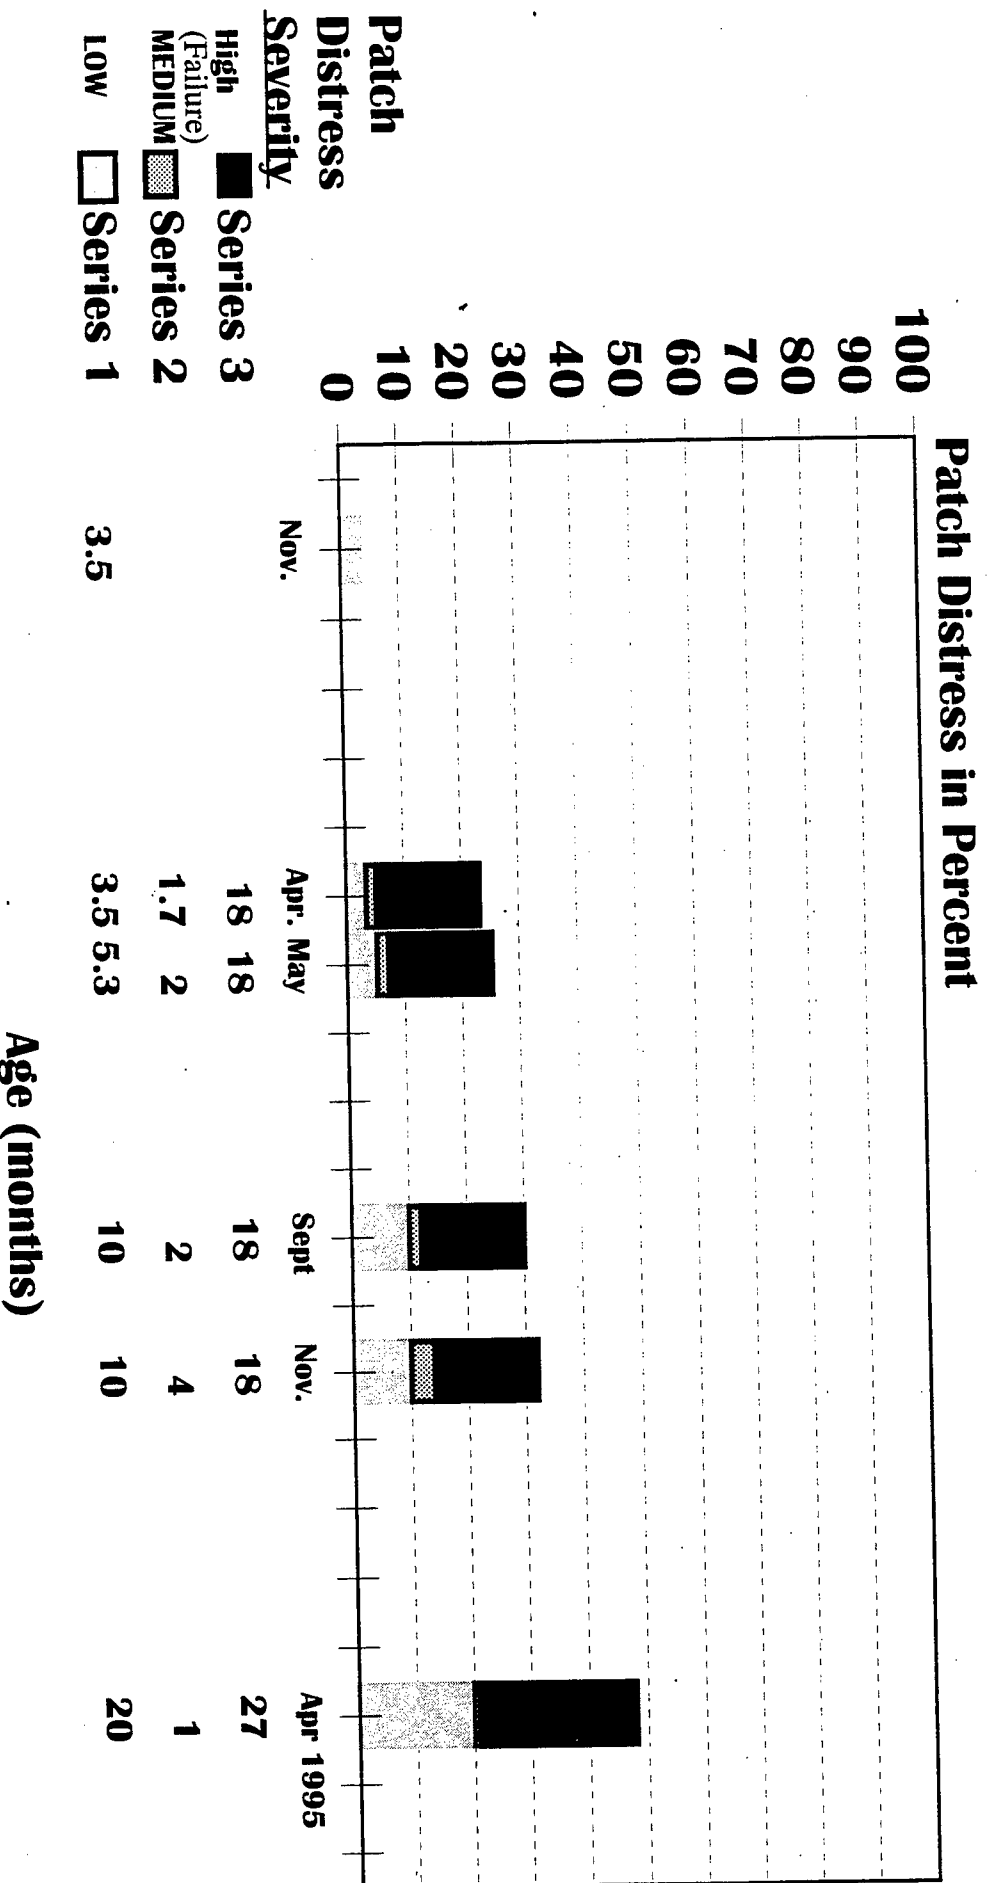
Figure 3. Conventional Class 'A' Patch Design

distress ranged from medium and high severity transverse cracking to pumping of fines and faulting, followed by patch failure. Seventeen percent of the conventional patches failed within 1 month, as shown in Figure 3. Many of these failures were severe in nature. It was evident that patch cracking resulted at existing steel junctions 1 month after construction when mechanical bar couplers were used instead of the lap-splice method. The data also showed a consistent deterioration rate with similar distress stages from patch to patch. However, the conventional Class A patch has a fair or moderate reliability if constructed according to standard policies and procedures.

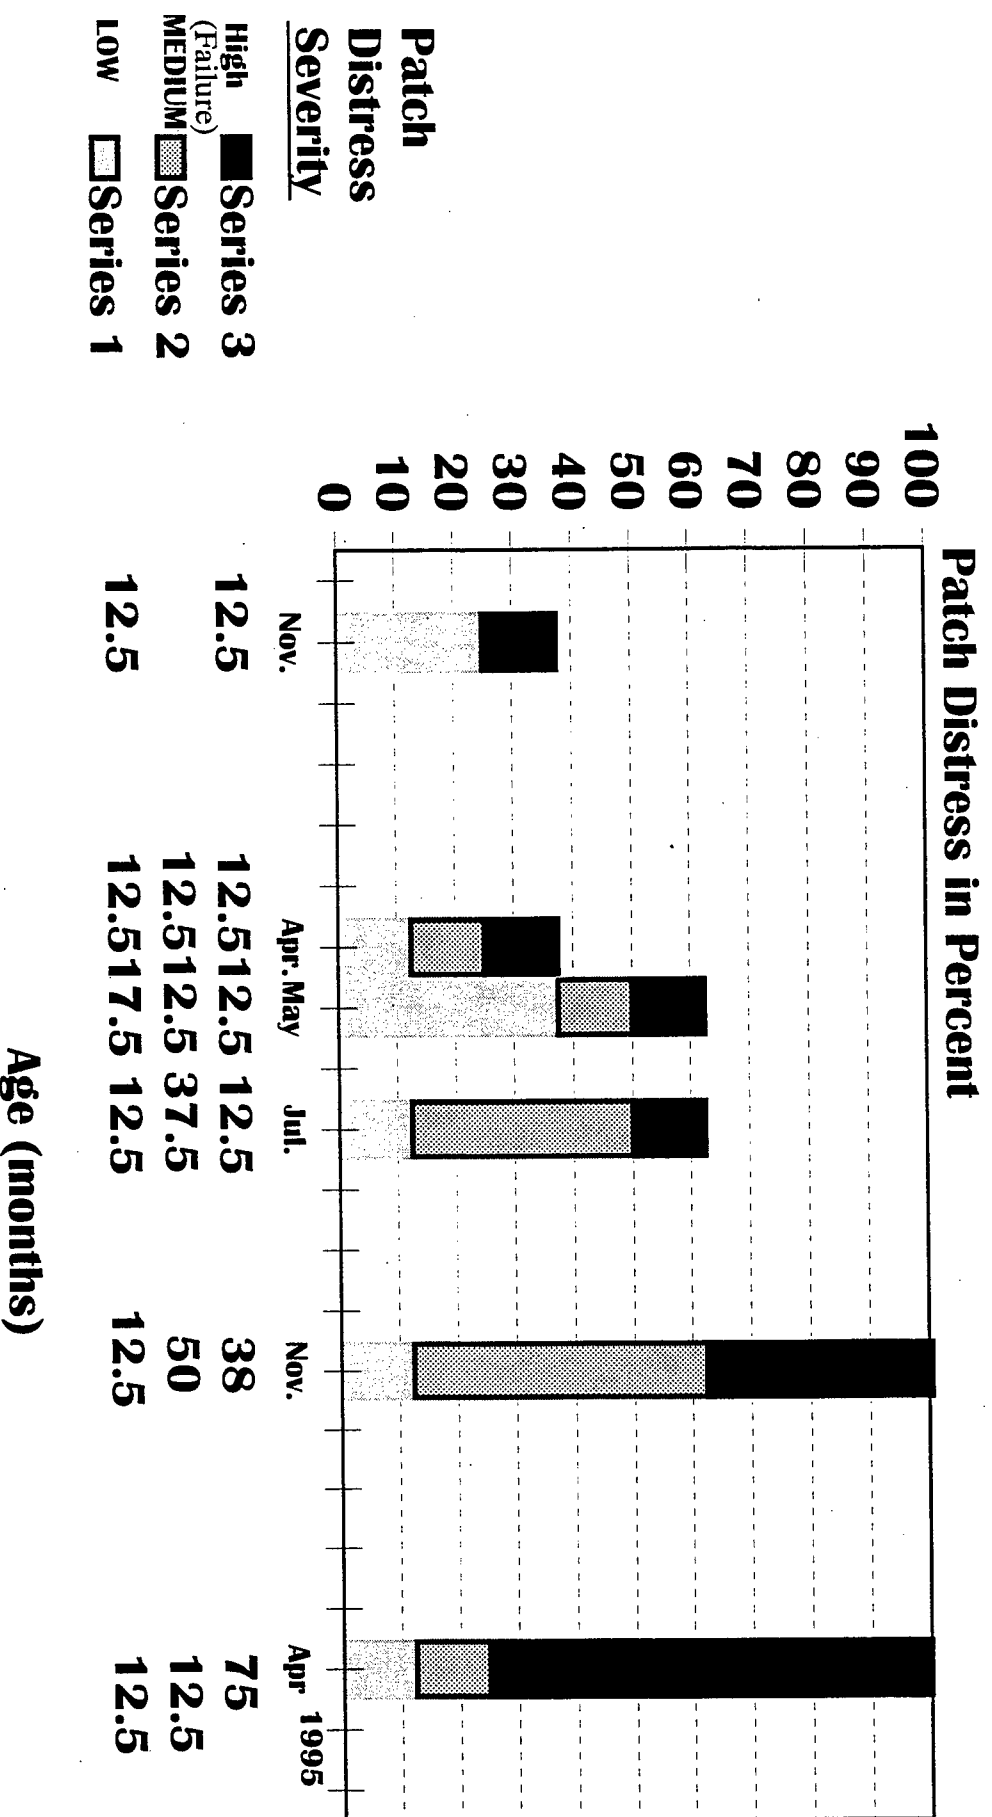
Figure 5. High-Early Strength Patch Design

Survey data analysis indicates an 80% patch failure rate after 2 years, as shown in Figure 5. Serious transverse cracks and spalling occurred at a higher rate than the standard concrete mixture. The surface of the concrete at Site 4 in Sangamon County appeared cracked or crazed (many fine cracks) soon after curing. The crack pattern produced pieces of concrete that eventually worked loose from the surface. It was noted that the recommended calcium chloride dose was exceeded. This may explain the surface crazing in the repair. Caution is needed in maintaining a maximum of 2% by weight of cement, and no more than 1% when the ambient temperature is above 80° F. This is to avoid a flash set and excessive heat of hydration. Further concerns on the use of calcium chloride include the corrosive properties imparted to the reinforcing bars. For further information, refer to the "Manual of Concrete Proportioning and Testing" issued January 1, 1988 (Reference 2).

High-Early Strength Concrete: The purpose of the high-early strength concrete patch was to obtain strength quickly. Care must be exercised in the dosage levels of accelerator additives to make sure rates are within recommended limits.

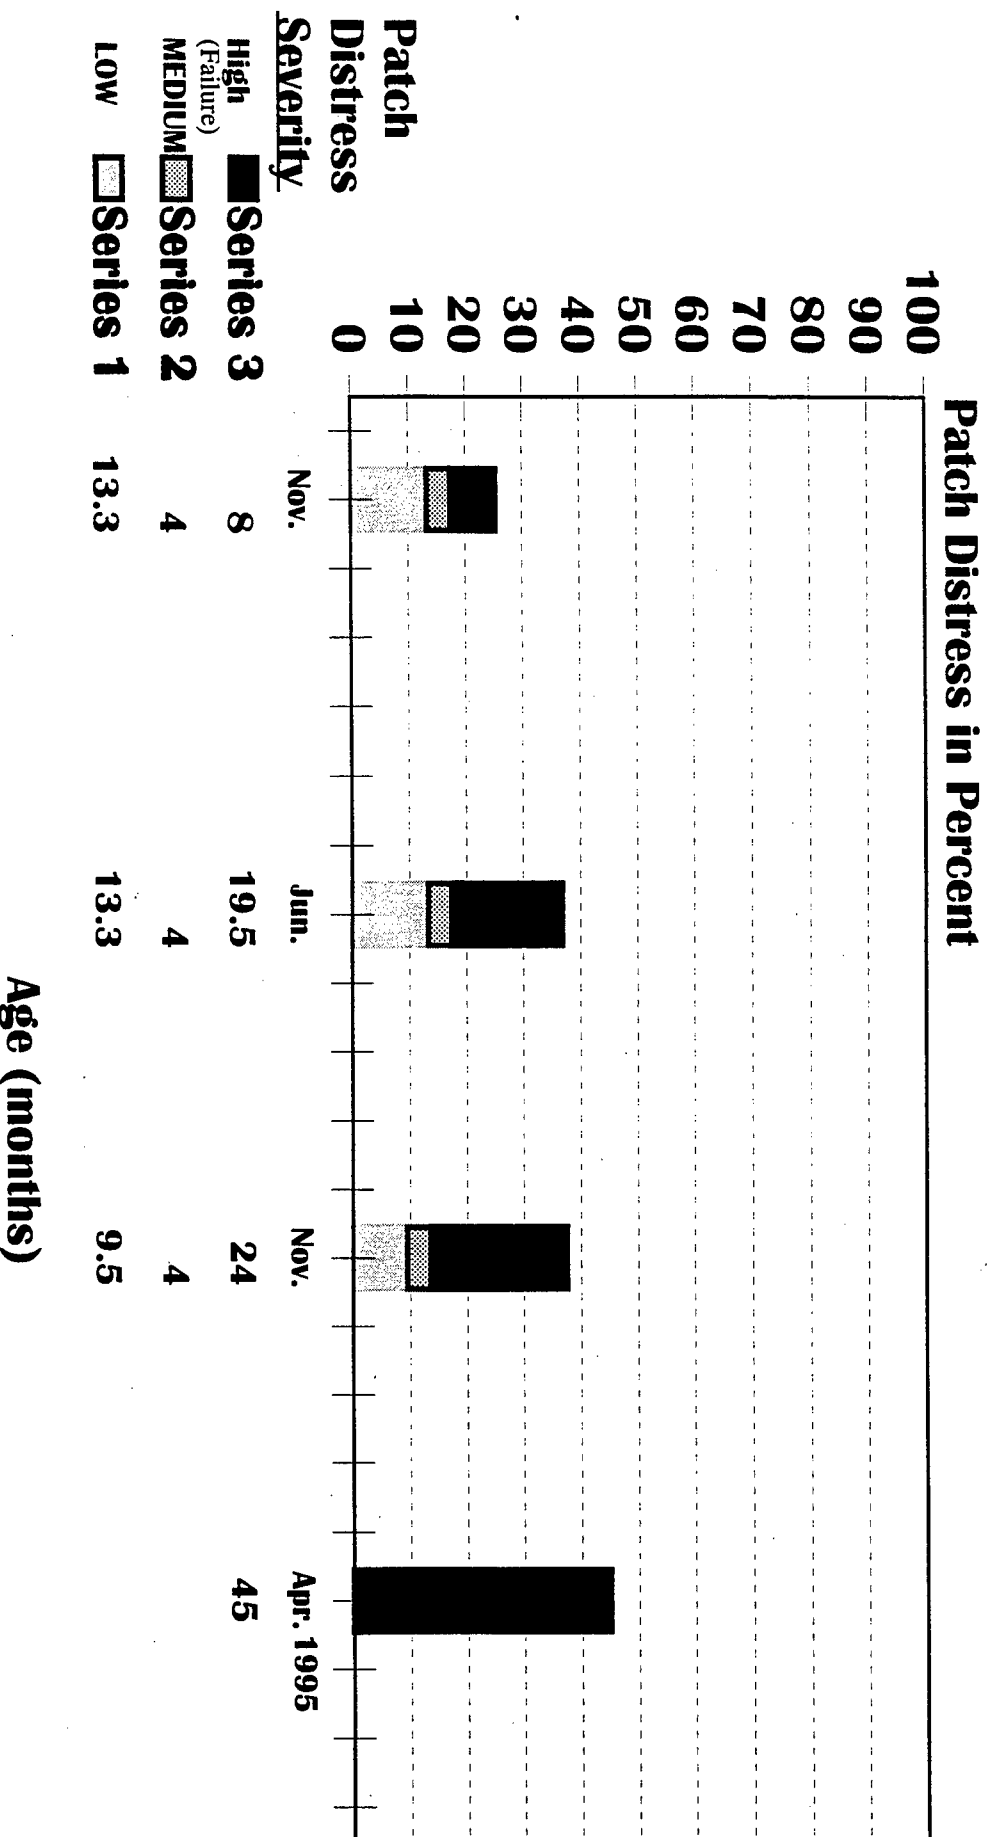
Figure 6. Drilled-Tied Patch Design

pavement removal. Between Site 2 in Macoupin County, Site 3 in Montgomery County, and Site 5 in Douglas County, 75 drilled-tied patches were constructed and studied. Survey data analysis indicates that 45% of the patches failed in the two-year study period (see Figure 6).

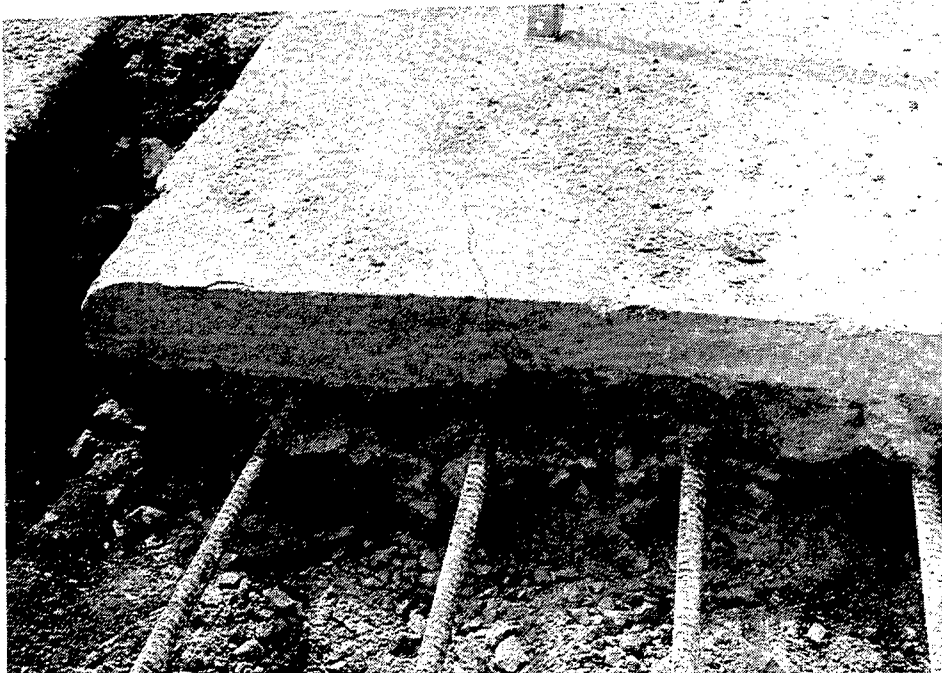
Photo 2. Corner break and undercutting from use of Skid-steer loader mounted jackhammer.

- Skid steer loader mounted jackhammers can cause excessive damage (nicking or bending) to the rebar to be lap-spliced, as well as the adjacent pavement. The equipment can also cause corner breaks. If not being used with care, skid steer loader mounted jackhammers should be removed from the job. The use of a skid steer loader mounted jackhammer is currently allowed through the use of the Special Provision for Class A Patches (Skid Steer Loader Equipped with a Hydraulic Hammer) which is checkmarked to allow its use on most contracts.

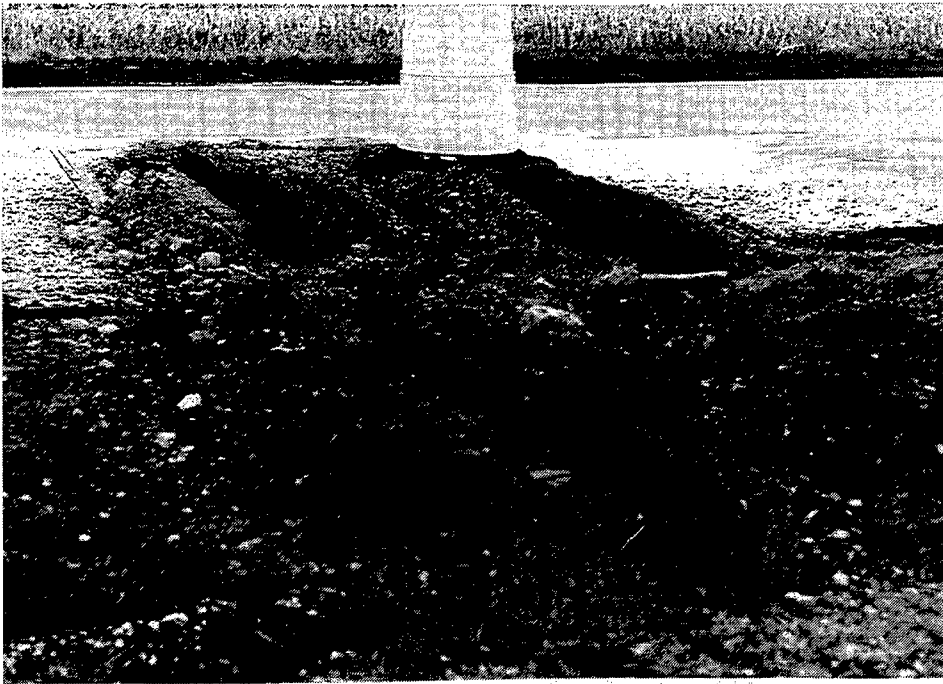
Photo 3. Interior saw cuts made by wheel saw, as shown, are too deep.

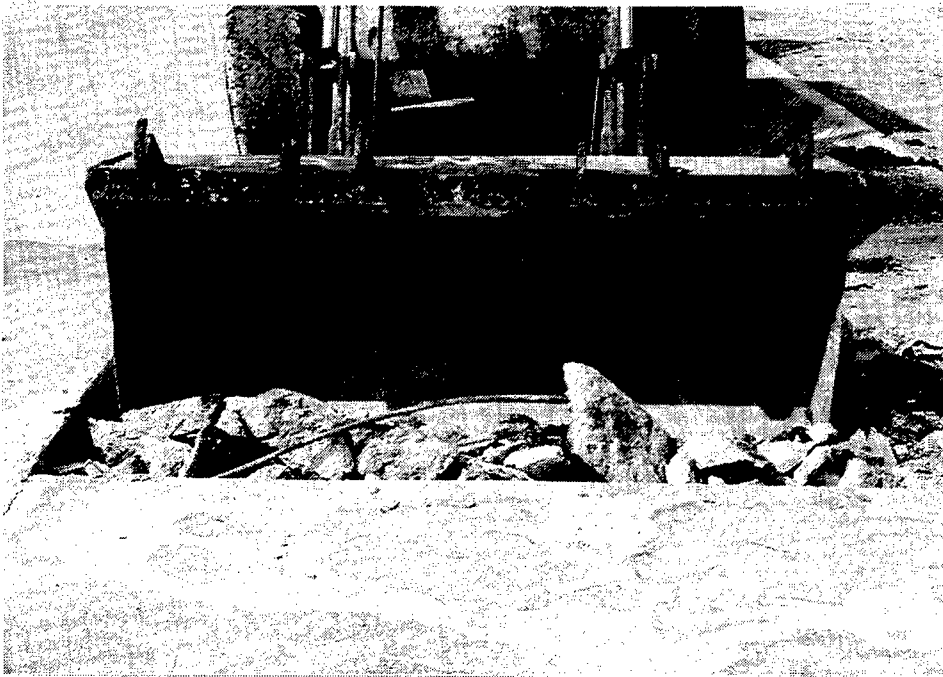
Photo 4. Backhoe bucket for concrete removal is not permitted. Procedure causes damage to adjacent pavement.

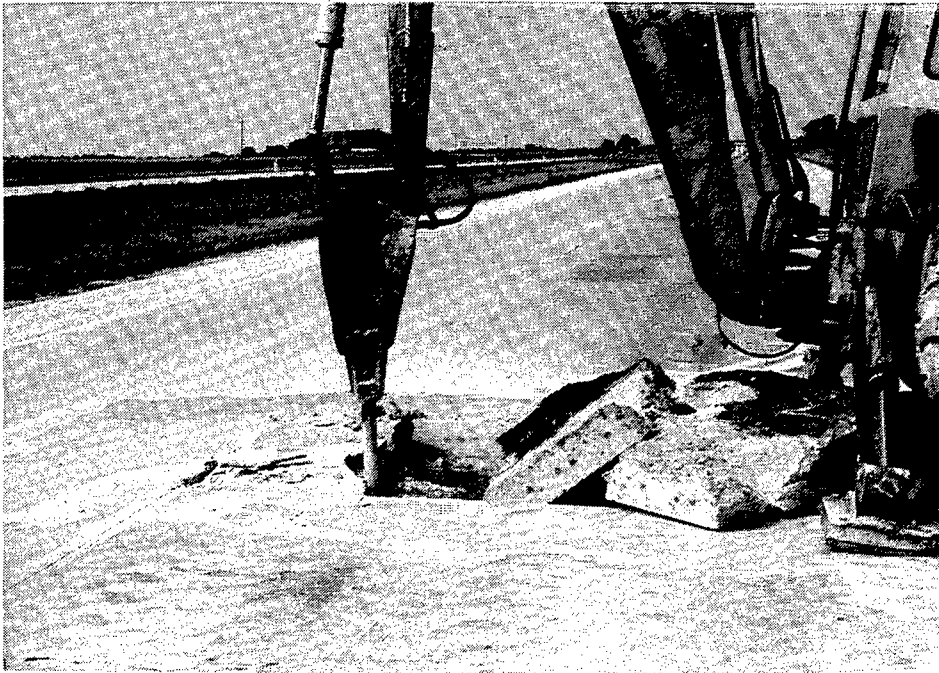
Photo 5. Backhoe mounted jackhammer is not permitted.
Causes damage to adjacent pavement and subbase.

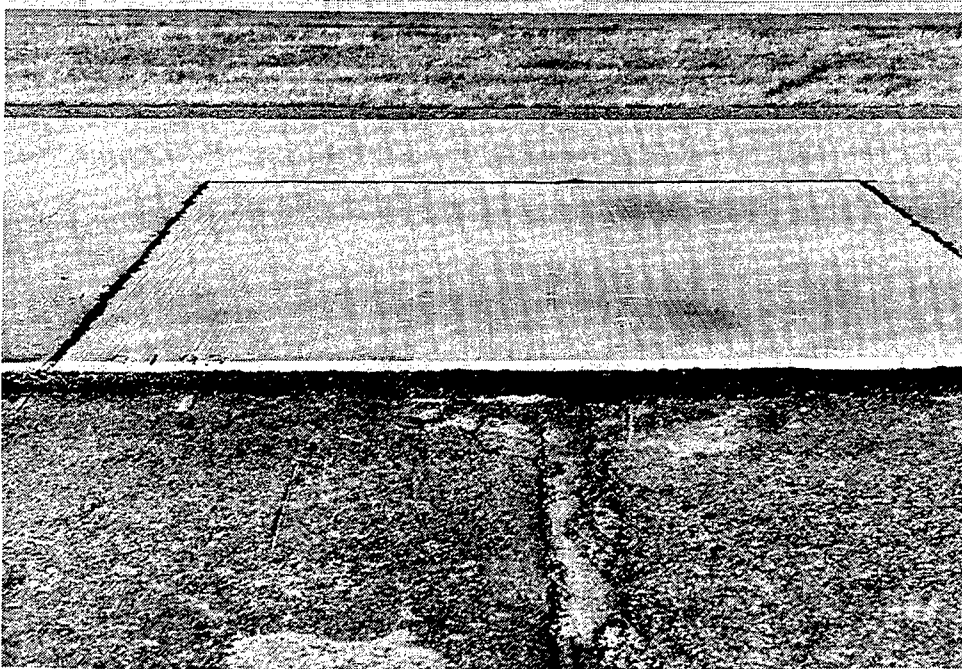
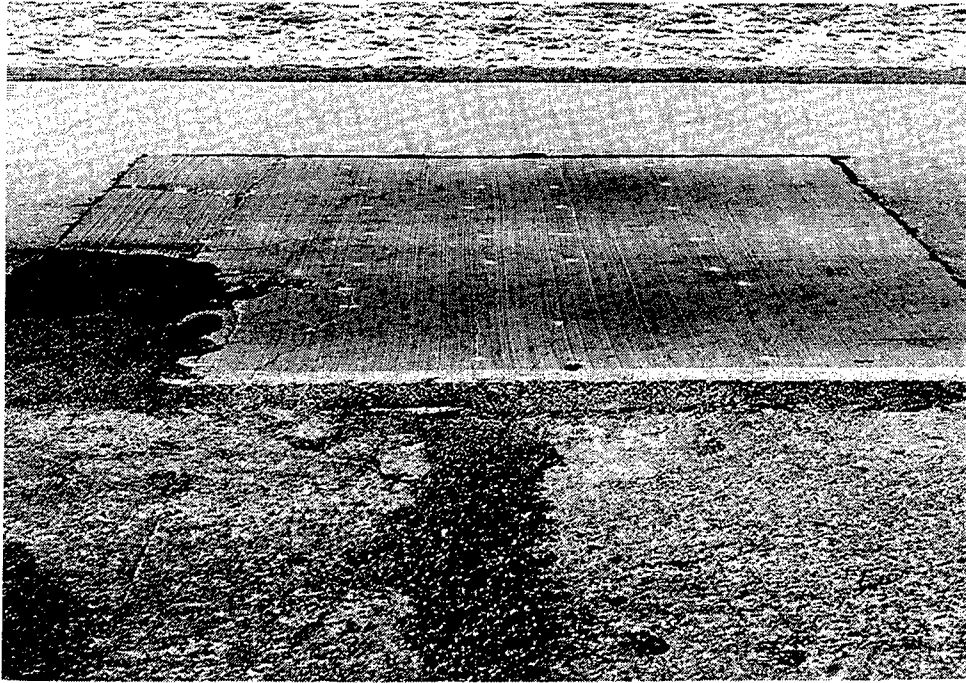
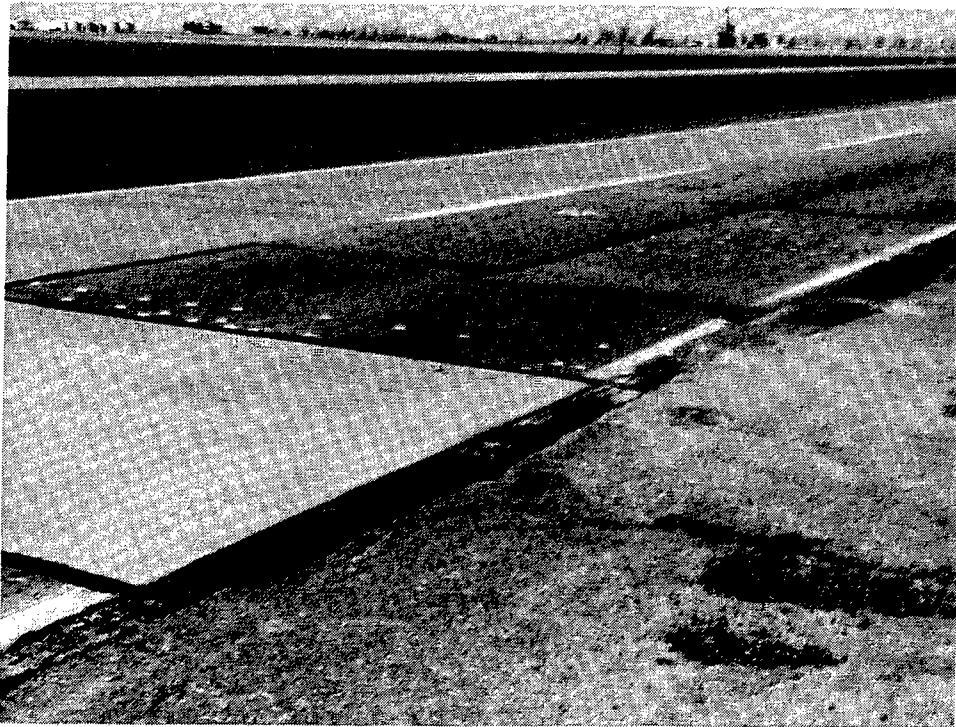
This design is more costly and time consuming than the average rate for the conventional Class A patch. There were 13 patches constructed and studied using this procedure. These patches were located at Site 5 in Douglas County. This site consisted of a highly deteriorated 180 mm (7-inch) thick CRCP, as shown in Figure 4. Survey data analysis indicates a 92% patch failure rate after 2 years. Inconsistencies in subbase support is believed to be the cause of failures. Due to the low number of patches constructed, the performance of this design may not be representative of statewide experience. Typical failures are shown in Photos 8-10.

Photo 8. Remove and replace subbase with 4 inches of PCC.
Age: 1 month

Photo 9. Remove and replace subbase with 4 inches of PCC.
Age: 4 months.

Photo 10. Remove and replace subbase with 4 inches of PCC.
Age: 1 year.

Repairs which included removal of the existing subbase performed poorly. Failure rates of replaced subbase sections ranged from 25% to 92% within 2 years. For this reason, existing subbase material should be disturbed as little as possible.

- Subbase materials should be disturbed as little as possible during pavement excavation.
- If subbase material is disturbed during pavement removal, or is unsound, replacement with bituminous material rather than PCC or aggregate is preferable.

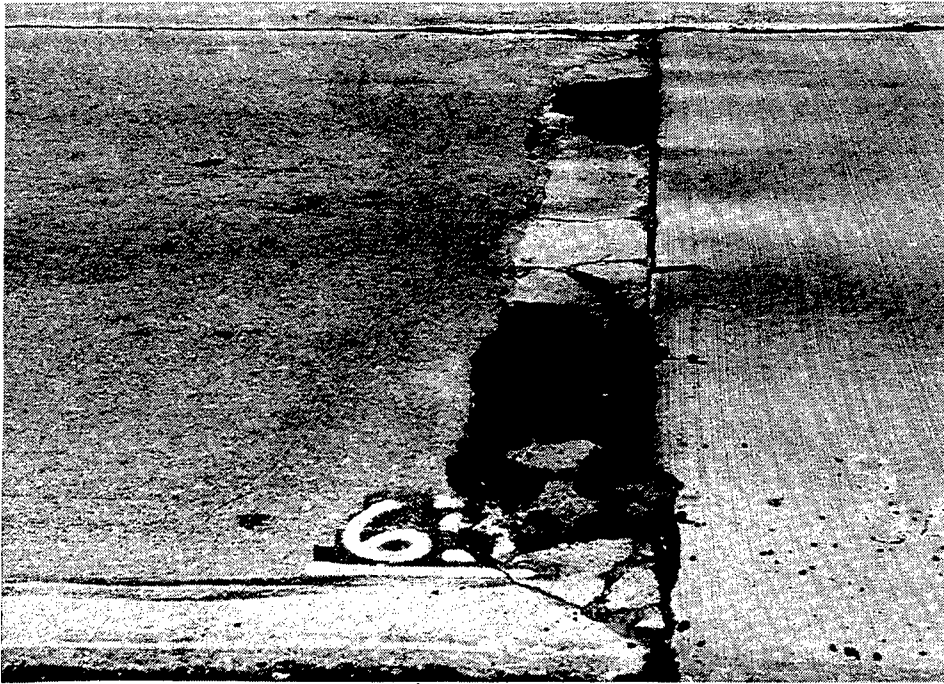
Patch distresses at all sites were remarkably similar and started at the drilled-tied ends in the old pavement (see Photo 11). Failures at the center of the patch were uncommon after the bars in the adjacent pavement became loose. The debonding of the existing concrete from the tie bars made them visible from the surface of the pavement. It was noted the shorter in length the patch was, the better the survival rate was. It was apparent that loading stresses were directly transferred to the patch joint that proved to be weaker than the patch concrete. This became the main mode of failure, which was repeated from patch to patch. Highly irregular transverse crack patterns of 0.15-4.5 m (0.5-15 feet) at Site 2 in Macoupin County caused an increase in patch distresses. Deeper tie-bar anchoring into the existing concrete has been used by others with limited success (see Reference 3).

Photo 11. Drilled-tied experimental design. Age: 4 months.

Drilled-Tied: The purpose of the drilled-tied CRCP patch was to prolong adjacent pavement life. The design did not meet this requirement and failures were numerous.

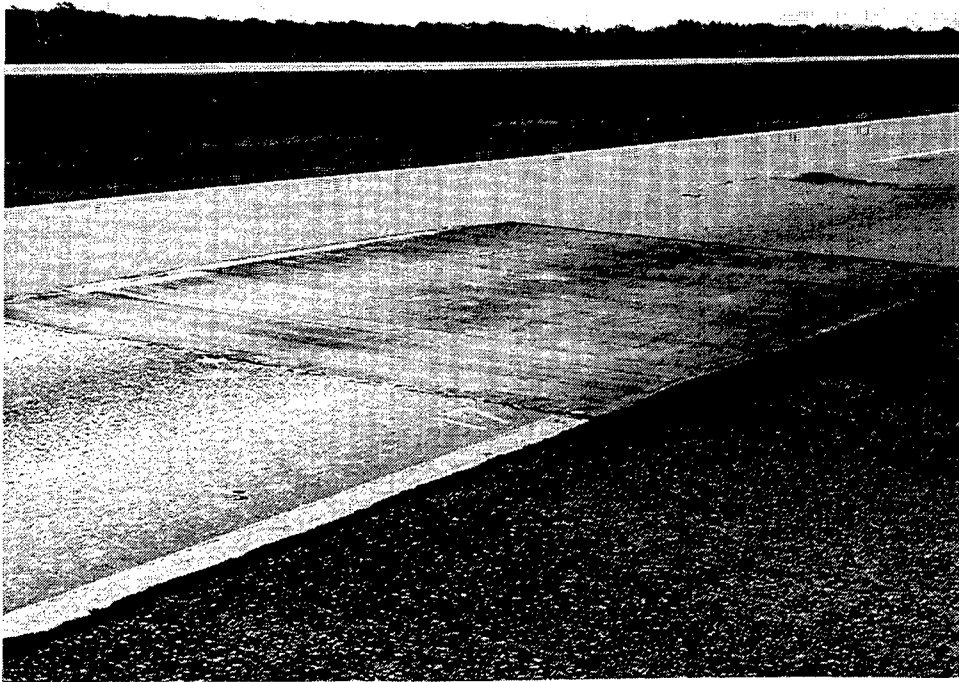
Patch joints were sealed using ASTM D 3405 hot poured sealant for 90 of the 132 patches. Refer to Special Provision for Joint Sealing Continuously Reinforced Concrete Patches. Photos 12 through 14 illustrate the hot poured sealant procedure. The 90 sealed patches were able to withstand large impact forces resulting from traffic loadings at all sites, but most notably, Site 1 in Logan County. Figure 7 shows a very low percentage of patch failures (4.5% after 18 months). Unlike other experimental CRCP patch designs in this study, the transverse rebar design did not have a high failure rate immediately after construction (see Photo 15).

Photo 15. Transverse rebar experimental design.
Age: 6 months.

Sufficient findings have been presented to recommend the Transverse Rebar CRCP patch design for implementation. The revised design has been approved by the department and Standard 2425-5 (now referred to as Standard 442001-01) has been revised to feature this design as the preferred method of pavement patching.

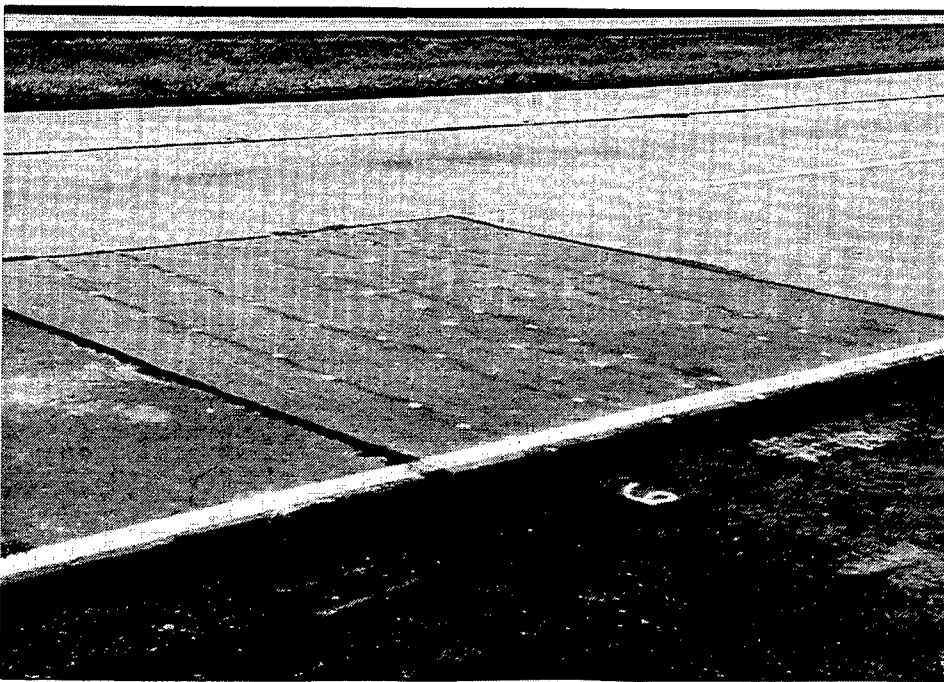
patches showed minimal distress at 2 months. Patches at Site 4 in Sangamon County contained only 44.5 Kg/cu. meter (75 lb/cu. yd) of steel fibers. These patches showed no improvement in performance over the conventional Class A patches. Patches of 7-inch CRCP at Site 5 in Douglas County contained 118.7 kg/cu. meter (200 lb/cu. yd) of steel fibers. These patches showed only marginal improvement (20% after 18 months) over the conventional Class A patches (see Figure 9). A reduced pavement thickness may have offset the strength gain of the steel fibers. The failure mode for the steel fiber modified concrete CRCP patch design was the formation of wide longitudinal and transverse cracks followed by punch outs, as depicted in Photo 16.

Photo 16. Steel fiber modified concrete experimental design.
Age: 6 months.

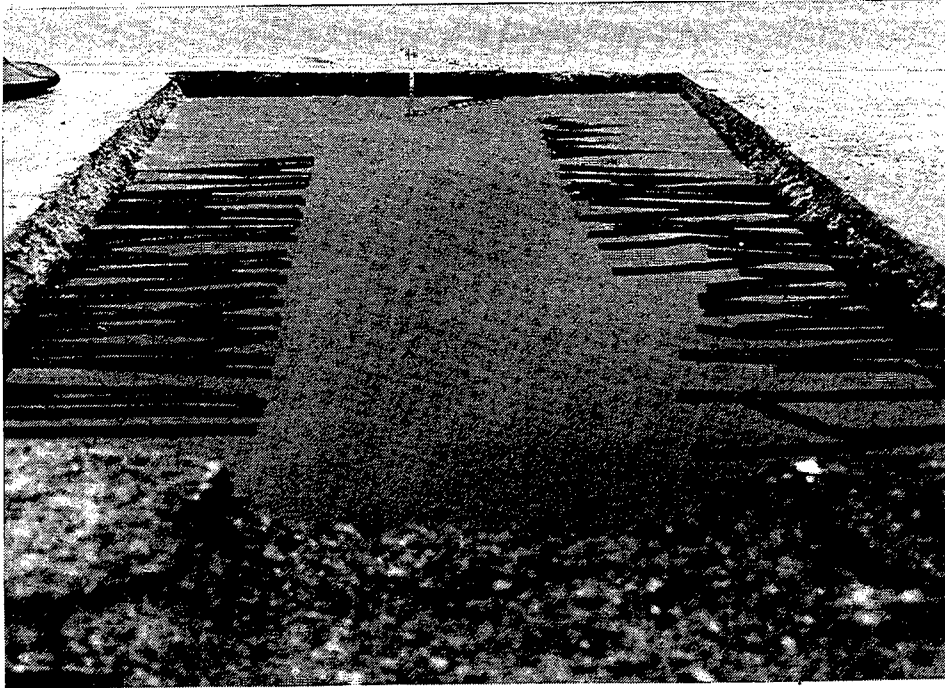
Photo 17. A weakened subgrade resulted from a saturated condition.

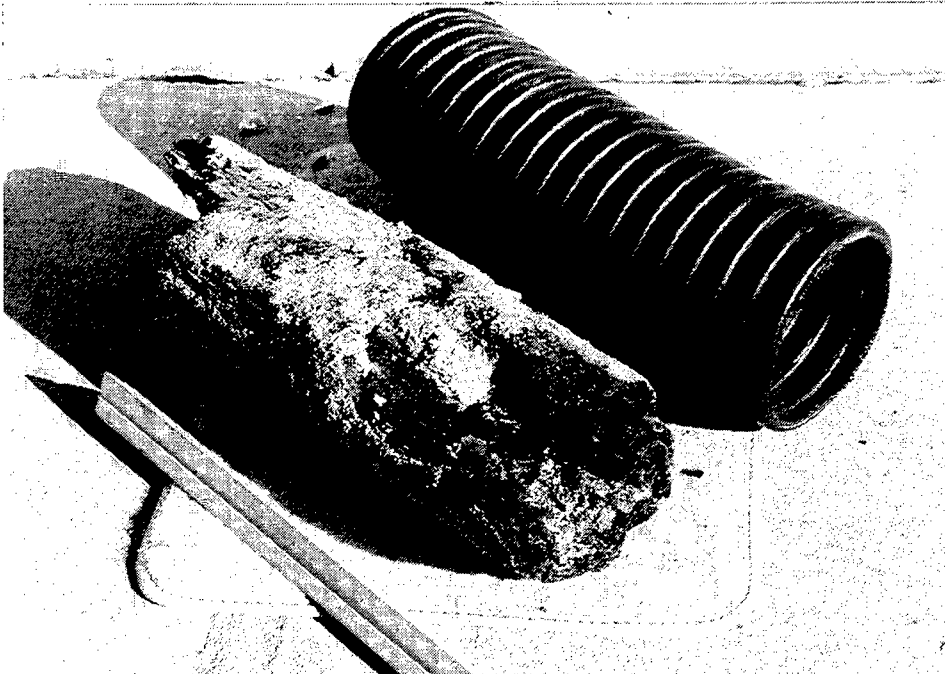
Photo 18. Deteriorated bituminous underdrain recovered during construction.

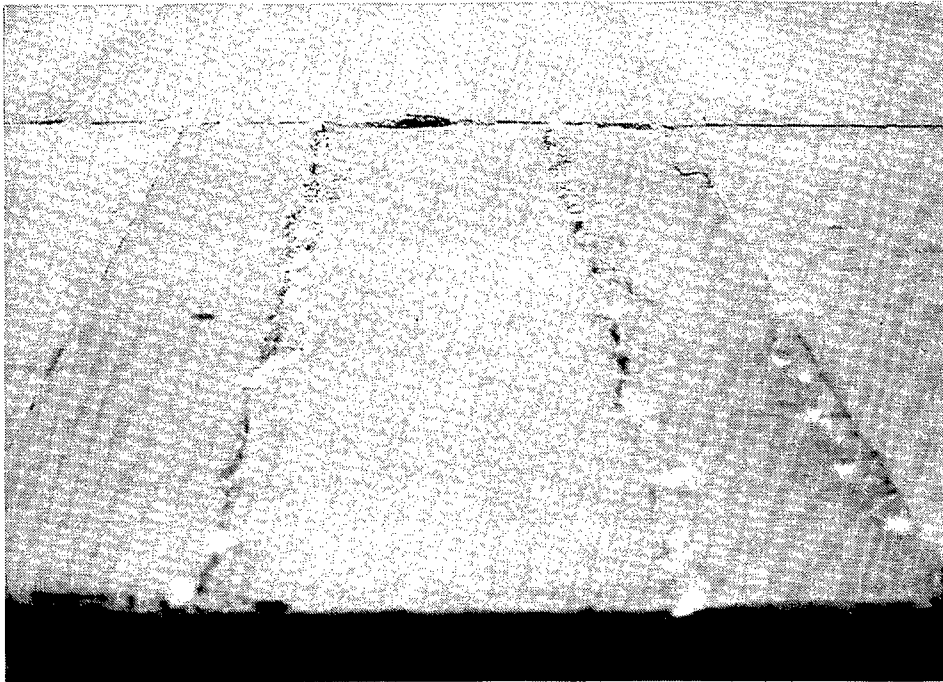
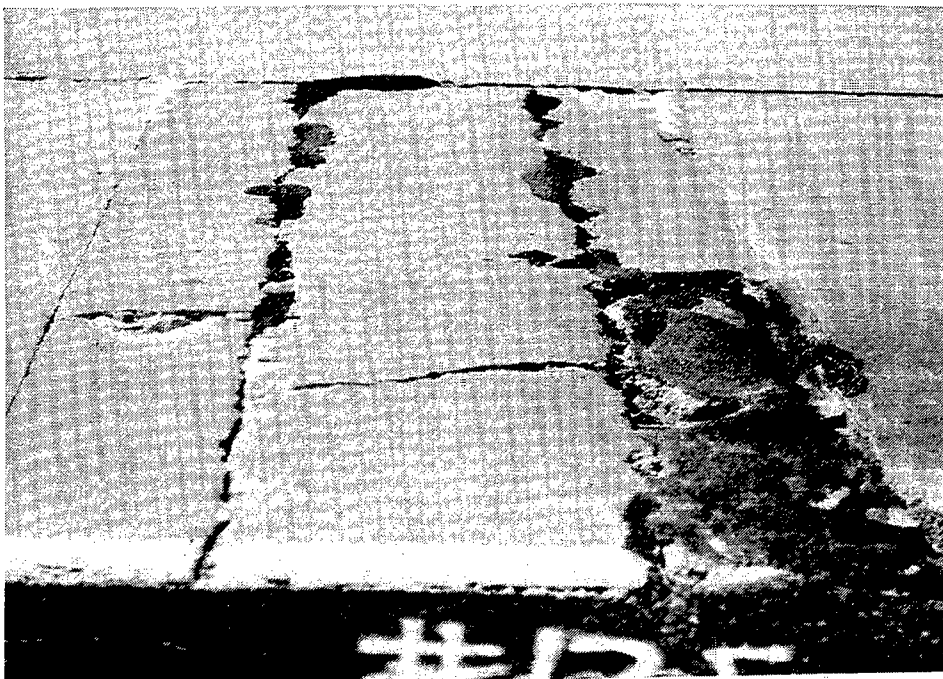
Survey data analysis indicates that over 75% of the patches failed completely in the two-year study period. Patch distresses ranged from spalling and longitudinal cracking to punch outs and pumping of fines. The design exhibited unexpected results with respect to the purpose of drainage. Figure 10 reveals an extremely high rate of patch failures. The fracture pattern of the majority of these patches showed that the excavation of the subbase between the rebar to be lap-spliced resulted in a loss of support between the rebar severed ends (see Photos 19-20). Drainage under the patch caused migration of subgrade fines, which washed through the underdrain network regardless of drain type. The drainage features actually allowed water to remain in the pavement, resulting in weakened subbase/subgrade support as indicated from CBR readings taken after the concrete was removed. It became evident that disturbance of the subbase/subgrade was responsible for the failures.

Photo 19. Drainage layer experimental design.
Age: 6 months

Photo 20. Drainage layer experimental design.
Age: 8 months

- Individual drains along the side of the pavement, such as French drains, can be installed when patching continuously reinforced concrete pavements. Patch drains can be beneficial, especially if the existing underdrains are not functioning, such as the bituminous fiber pipe found in Logan County. Removal of the subbase and replacement with a drainage layer under the patch should not be allowed as this greatly increases the failure rate of the patch.
